# Manhole Inspection Summary

Manhole # S01GG2004MH

Insp Date: **8/8/06 11:33 AM**

**Location** Address: **3101 Fallstaff Rd**

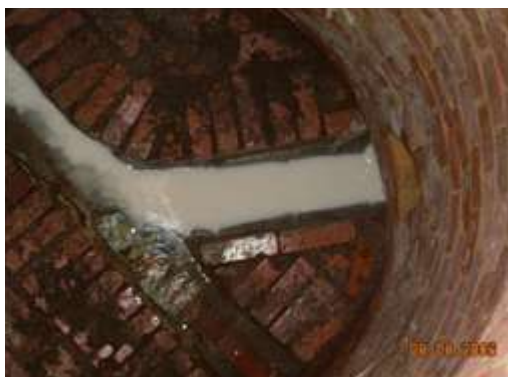
white flow

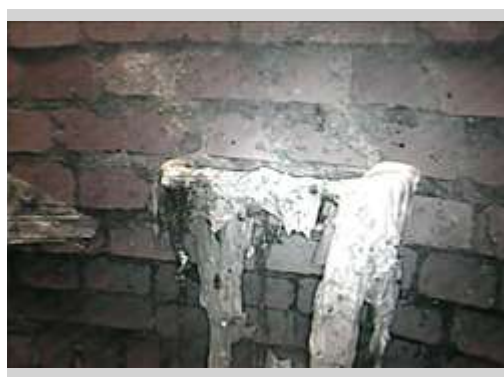
Defect

☒ **Evidence Of Surcharge** Depth: **5** (ft.) ☐ Active Surcharge Present

evidence of surcharge

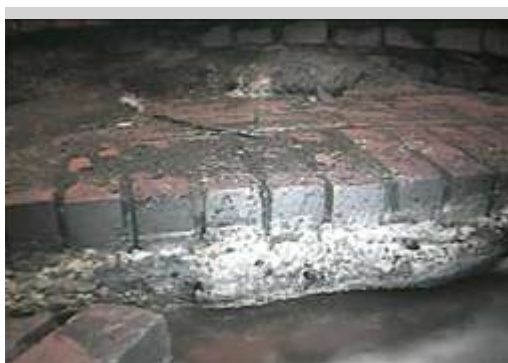
Defect

Condition: ☐ Sound ☐ Cracked ☐ Root Intrusion ☐ Deteriorated ☐ Leaks ☒ **Debris**

Grease in channel

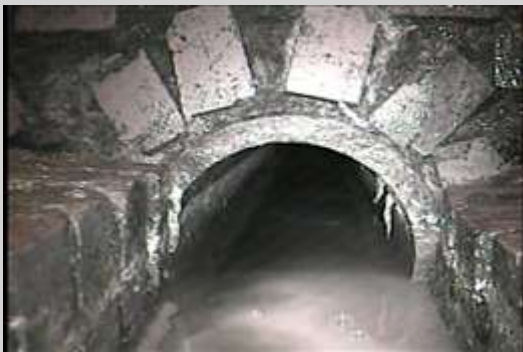
### 8 in. Circular Gravity Sewer Pipe Out @ 12 O'Clock

Invert Depth: **10.90** (ft.) Flow Characteristics: **Slow**

Deposits: ☒ None ☐ Mud ☐ Sludge ☐ Debris ☐ Grease

Infiltration: **None** Pipe Seal Cond: **Sound**

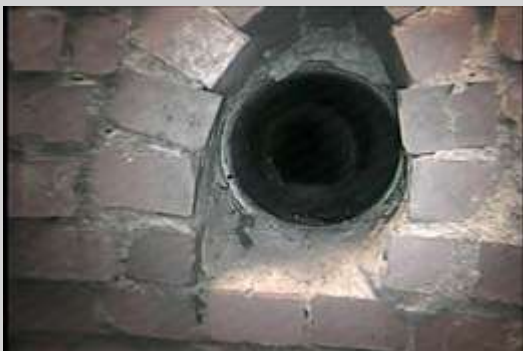
### 8 in. Circular Gravity Sewer Pipe In @ 4 O'Clock

Invert Depth: **7.55** (ft.) Flow Characteristics: **Slow**

Deposits: ☒ None ☐ Mud ☐ Sludge ☐ Debris ☐ Grease

Infiltration: **None** Pipe Seal Cond: **Sound**

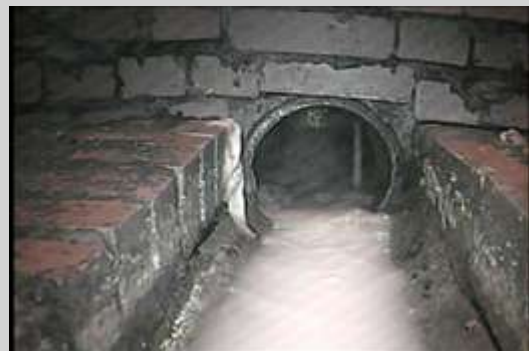
### Drop In @ 4 O'Clock

Drop: **Outside** Rod and Bar

Angled: **Yes** Reading: **9.81** (ft.)

Inv Depth: **10.81** (ft.)

Drop Condition: **Open**

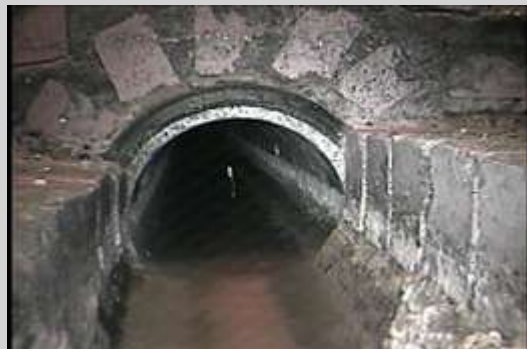
Pipe In @ 6 O'Clock

Invert Depth: **10.80** (ft.) Flow Characteristics: **Slow**

Deposits: ☒ None ☐ Mud ☐ Sludge ☐ Debris ☐ Grease

Infiltration: **None**

Pipe Seal Cond: **Sound**
